DOCUMENT NUMBER: MTN-0001C-17-NA
 APC: 470,481, 756
 ISSUE DATE: 01-2017
 EXPIRATION DATE: 31-12-2019
 Bulletin Type: Informational Only

Motorola Solutions Technical Notification (MTN)

TITLE: Premature low battery alert and/or battery shutdown with SRX2200BN / APX6000BN radios and NNTN8930A Batteries

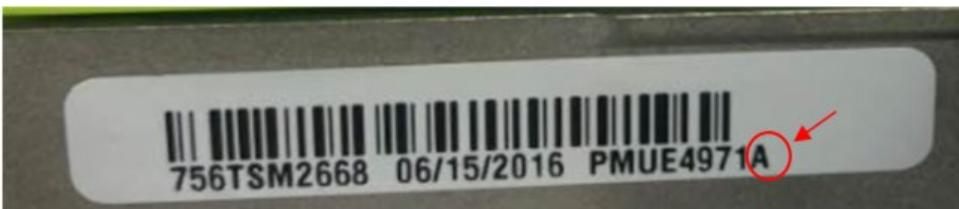
Hardware Revision location is on the left side wall of the radio's battery compartment, as denoted in pictures below.

STEP 1: Rework APX6000BN (Revision A Hardware Only) - Skip Step 1 and proceed to Step 2 IF radio is Revision B hardware or later.

For APX 6000 BN radios with Revision A Hardware (PMXXXXXXA) AND with the serial number range 470/481/756CSQxxxx - 470/481/756CSXxxxx will require radio to be sent to the Federal Technical Center or Motorola Canadian Technical Logistics Center for repair. If the radio is Revision A hardware, but NOT within the designated serial number range, then radio board modification is NOT required - proceed to Step 2.

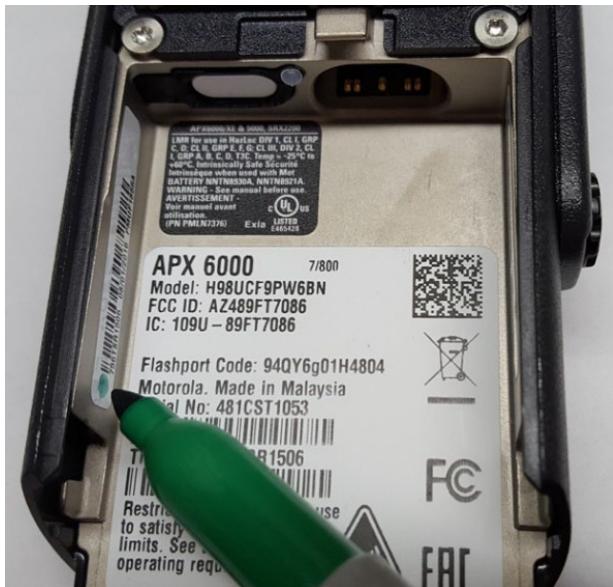
A radio that already has a green dot on the left sidewall of the radios battery compartment (as shown below), indicates the radio is a Rev A version that has already had the board modification done, and therefore will not need to be sent to the depot.
