DOCUMENT NUMBER:	MTN-0062D-24
ISSUE DATE:	2024-05
EXPIRY DATE:	2026-12

MOTOROLA SOLUTIONS TECHNICAL NOTIFICATION (MTN)

APX/PCR RSM Cable Jacket separation/fraying exposing internal wires

Accessory - APX/PCR Remote Speaker Microphones

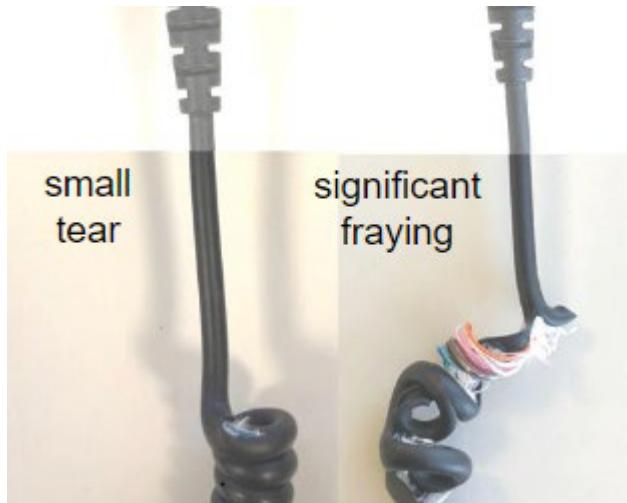
The RSM cable jacket tears or frays and exposes the internal wires. See the example picture below.

Cable tear or fray is a condition in which:

- the RSM cable black outer jacket develops frays that get worse with use
- the inner cable contents become visible
- typically occurs at RSM head or radio connector (GCAI) end or both, but can also occur in cable middle section.

Motorola RSM cable jacket material was changed in 2013 in order to comply with changes in global environmental material regulations. In the RSM cable application, the compliant jacket material has demonstrated a greater susceptibility to tearing at points of stress induced when the coil is elongated or stretched. How the RSM is positioned on the body (i.e across the back and over the shoulder vs. along front of the body - see picture) directly affects potential induced coil stress.

Susceptibility to the cable jacket tear phenomenon has been significantly reduced by increasing the coil diameter and/or cable length which effectively reduces coil cord stress. Motorola strongly recommends RSM users to dress the RSM coil section of the cord in such a way that it does not get caught on uniform accessories and equipment or equipment worn on the person for optimal RSM service life.

Motorola will extend the cable warranty to 30 months (18 months beyond the standard 12 month RSM warranty period) for units that exhibit the cable fraying issue. The Replacement of RSM or cable can be obtained by calling 800 MSI HELP, request for Order Management when prompted.

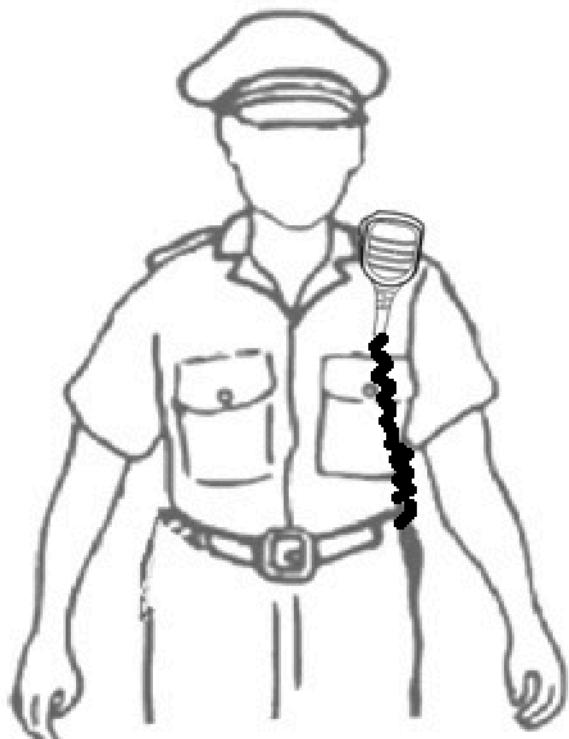
Low Stress wearing position

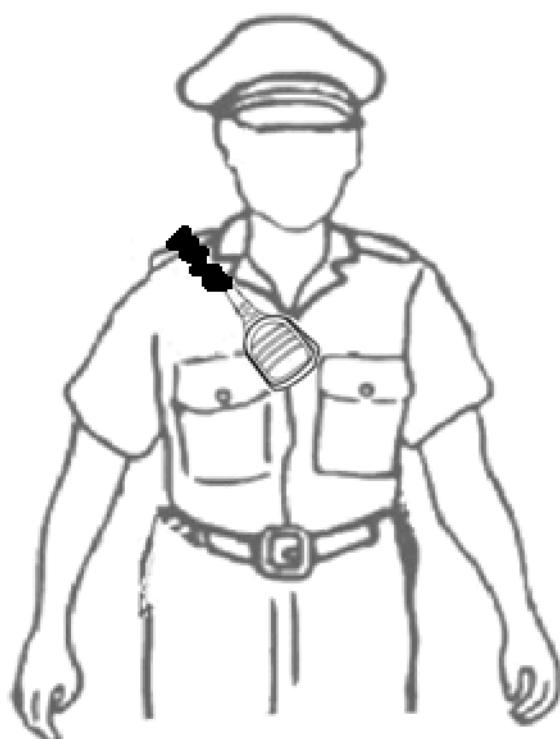
High Stress wearing position
